TOYO TIRE TALK

No.06-002 (TTT-182)

6th April, 2006

Subject : Indentation or Bulge in the Sidewall

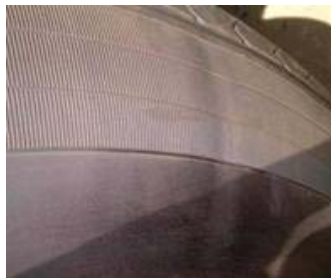
An indentation in the sidewall is usually cosmetic, and the tire can remain in service. On the other hand, however, a bulge in a sidewall means (in most cases) broken ply cords or thin sidewall thickness, and such a tire must be removed from service immediately and scrapped.

Sidewall Indentation

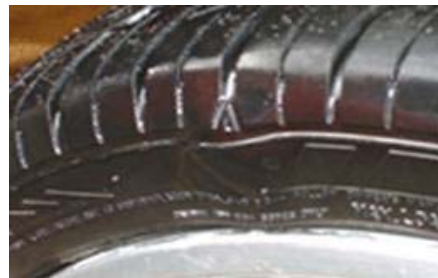
Sidewall Bulge

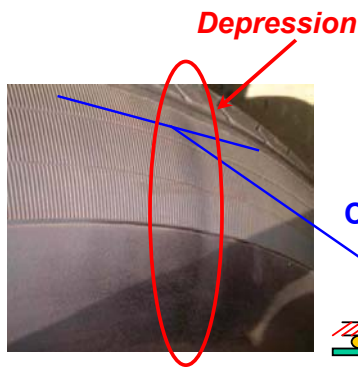
Indentation is usually seen at or around the carcass ply joint, and is more common with a tire of high section height.

The carcass ply joint is overlapped at the building stage as shown below. When the tire is inflated, the sidewall stretches less at the joint area than the remainder of the tire because it is stiffer there, thus creating a depression in the radial direction (photo at left).

Although this appearance may not be favourable, it is just cosmetic and the tire can be used. This is more noticeable in high inflation pressure LTR tires.

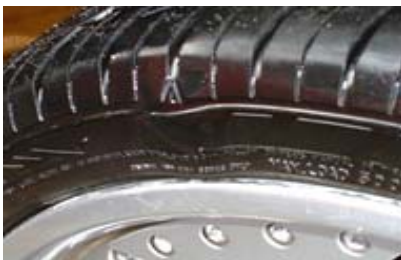
A sidewall bulge or protrusion is usually due to broken ply cords resulting from impact damage by kerbs or potholes. As the sidewall strength is considerably reduced at this area, keeping such a tire in service is dangerous. Such a tire must be demounted immediately and scrapped.

Other possible causes for this condition include mounting damage, punctured tread, improper repair, pinch shock etc. On a brand new tire, a bulge may be associated with a manufacturing condition.

Regardless of the actual cause, any tire with a bulge or protrusion must be permanently removed from service.

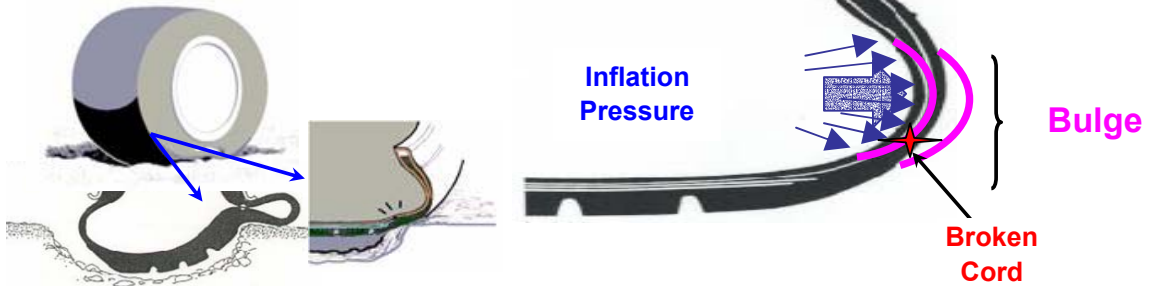
Carcass plies are broken by a shock due to hitting a pothole or a kerb.
