TOYO TIRE TALK

No.06-002 (TTT-182)

6th April, 2006

Subject : Indentation or Bulge in the Sidewall

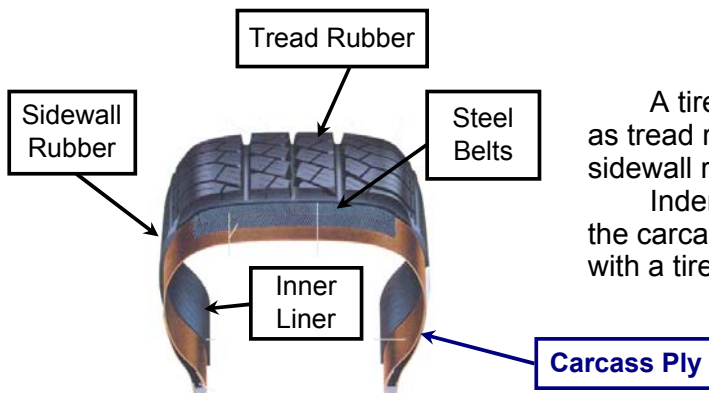
1. Indentation (Depression or Concavity) in the Sidewall.

A tire is composed of many parts, such as tread rubber, steel belts, carcass ply, sidewall rubber, beads and so on.

Indentation is usually seen at or around the carcass ply joint, and is more common with a tire of high section height.

The carcass ply joint is overlapped at the building stage as shown below. When the tire is inflated, the sidewall stretches less at the joint area than the remainder of the tire because it is stiffer there, thus creating a depression in the radial direction (photo at left).

An indentation in the sidewall is usually cosmetic, and the tire can remain in service. On the other hand, however, a bulge in a sidewall means (in most cases) broken ply cords or thin sidewall thickness, and such a tire must be removed from service immediately and scrapped.
